CAST COLUMNAR BRANCHING

Cast Columnar Branching is a process used to create asymmetrical columns, without any re-bar reinforcement, using Ultra High Performance Reinforced Fiber Concrete (UHP-FRC). With the latest technology today we are able to design non-euclidian geometry using computationally controlled parametric functions that allow us to determine, with precise accuracy, the optimal structural performance criteria. With the help of more affordable material for formwork, the process for developing concrete columns becomes much more desirable. Branching concrete columnar structures offer a unique opportunity to merge biomimetic form with structural geometry by implementing computationally controlled performance criteria. Because of advancements in the software used in the design and development process, precision of geometry or the ability to understand forces associated with asymmetrical loading, are no longer limited.

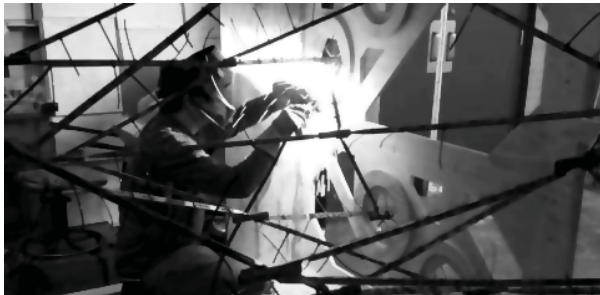
REINFORCEMENT

Initial designs incorporated concrete which required steel reinforcement. Standard reinforcement was not applicable in this situations. Custom reinforcement was necessary. Flat steel was cut specifically to length then custom cut down to match to the specific geometry of the formwork. Which also required custom compression rings.

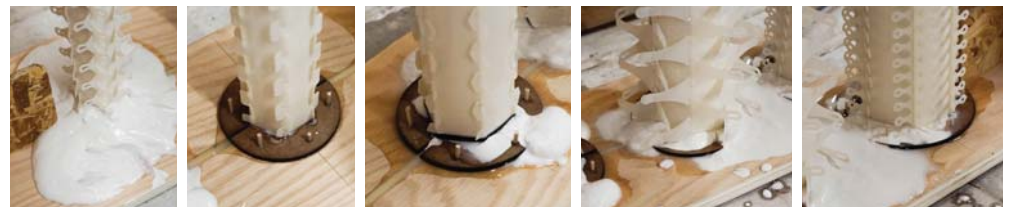
CASTING

Most of the leaks at the base of the formwork were due to a failure in either the compression ring or design of the formwork in CAD. There were no “blowouts” due to a high amount of hydrostatic pressure. The Hydro-Stone casting material was purposefully mixed as a more runny mixture to really test the tightness and seal of the seam-work. The end results were a success in that there were no significant leaks along the tabs and the leaks that did occur happened at the base which is fixable by a more thorough investigation at this area.

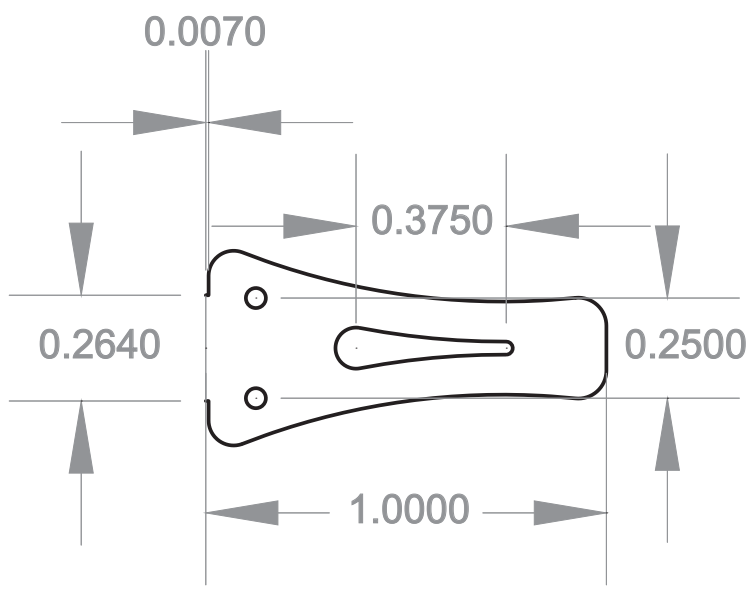
FINAL TAB DESIGN

After multiple tests with different tab designs, it became clear of what the final tab design needed to be. The overall length had to be just long enough so that grasping with the fingers would be comfortable. After contact with YO-CY we learned that this ideal length would not be suitable for the moment the tabs came about a large curvature in geometry. Therefore, it was decided that the length be reduced to no less than a half-inch. As for the width of the tab, this remained constant and true to all test subjects. This width size allowed for the casted specimen to reveal much smaller seam compared to a larger width. Gap size remained a constant half thickness of the Mylar (0.014) at 0.007 to maintain the tightest seal allowable due to the material. While this seemed to have caused a rippling effect on the formwork, it was a very small detail. Time became a precious resource for this project and there were many variables we had to take into consideration. The cutout holes on the tab were there as a precautionary means of constructing a secondary reinforcement incase there was moment of blowout. Ultimately our hypothesis became that early testing of the Mylar material showed great signs of tensile strength and resistance due to hydrostatic pressure. Therefore, in order to cut laser cutting time and costs down these interior cutouts were removed.

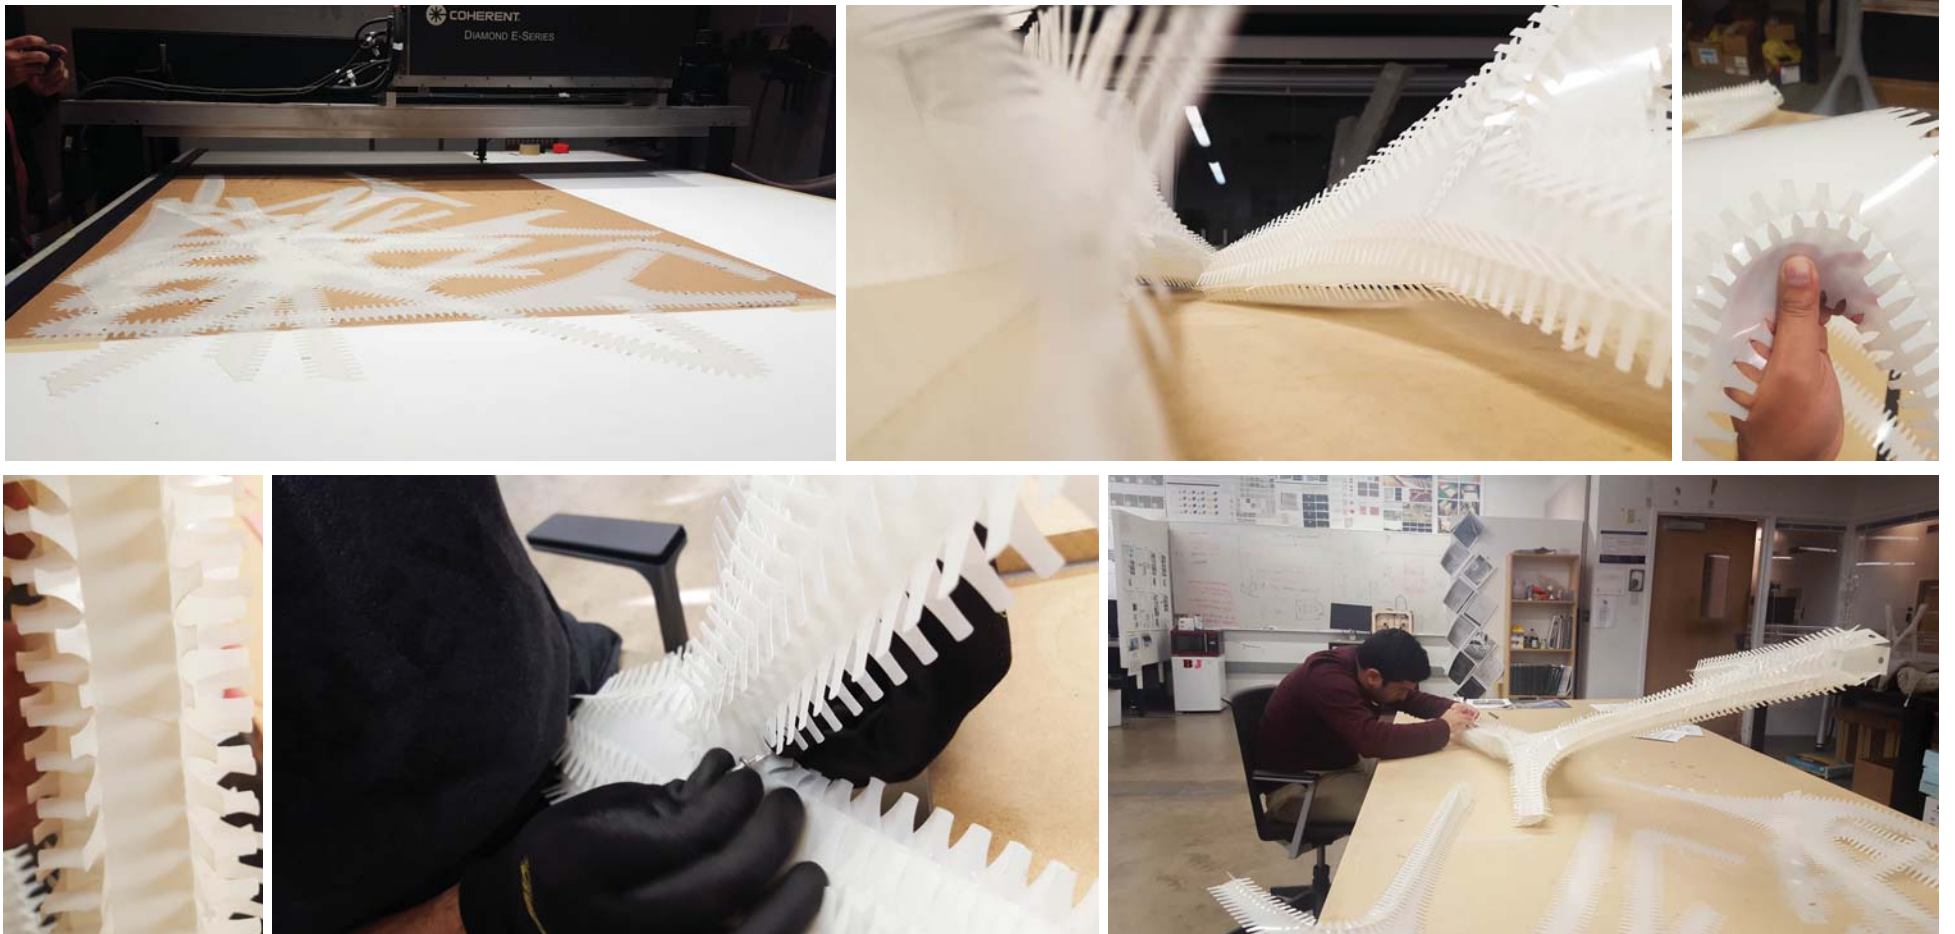
ASSEMBLY

We were able to get in contact with Dragon Street Laser in Dallas, a local facility with a large size laser cutter, to help us in manufacturing the pieces provided by Yo-Cy. Once pieces were cut from Dragon Street Laser we began assembly of the formwork. The average cut time per geometry was roughly 8 to 12 hours. The average assembly time of the formwork was 12 hours with two people.

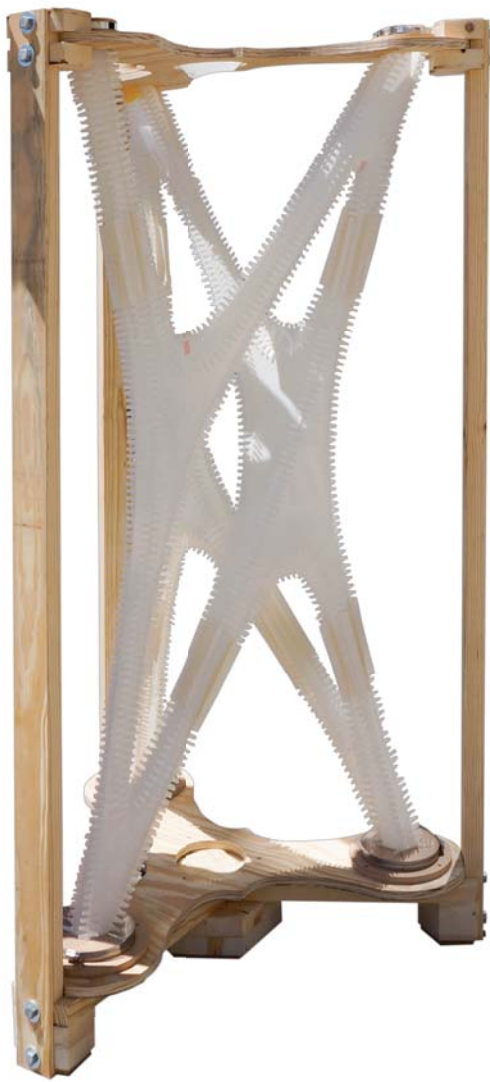
CONSTRUCTION

38" x 33" x 68" Scaffolding for Massing 4

Scaffolding design for Massing 4 began early in the process on assembling the formwork for Massing 4. The understanding of the compression rings helped shape the design of the scaffolding. A few things were also taken into consideration such as, the mobility of transporting the structure to and from the Architecture building and Civil Engineering Building, the ability of the upper and lower formwork connection points to have the ability to adjust based on the pressures of the UHP-FRC within the formwork once cast without allowing for movement vertically, and to minimize the amount of scaffolding to allow for maximum vision on the formwork for casting and analysis.

The scaffolding arrived to the Civil Engineering building without that top plate to ensure stability throughout transportation. The Upper Plate was then assembled on site, followed by attachment of Upper Compression Rings. There was a miscalculation with the inner acrylic rings, therefore, the Upper Compression Rings were rendered inoperable. To resolve this issue, a single screw at each top node was placed to hold the formwork up.
